PALLISER DOWNS STAGE 1A

GEOTECHNICAL COMPLETION REPORT

Cabra Rural Developments Limited / Rahopara Farms Limited

AKL2019-0017AF Rev 2

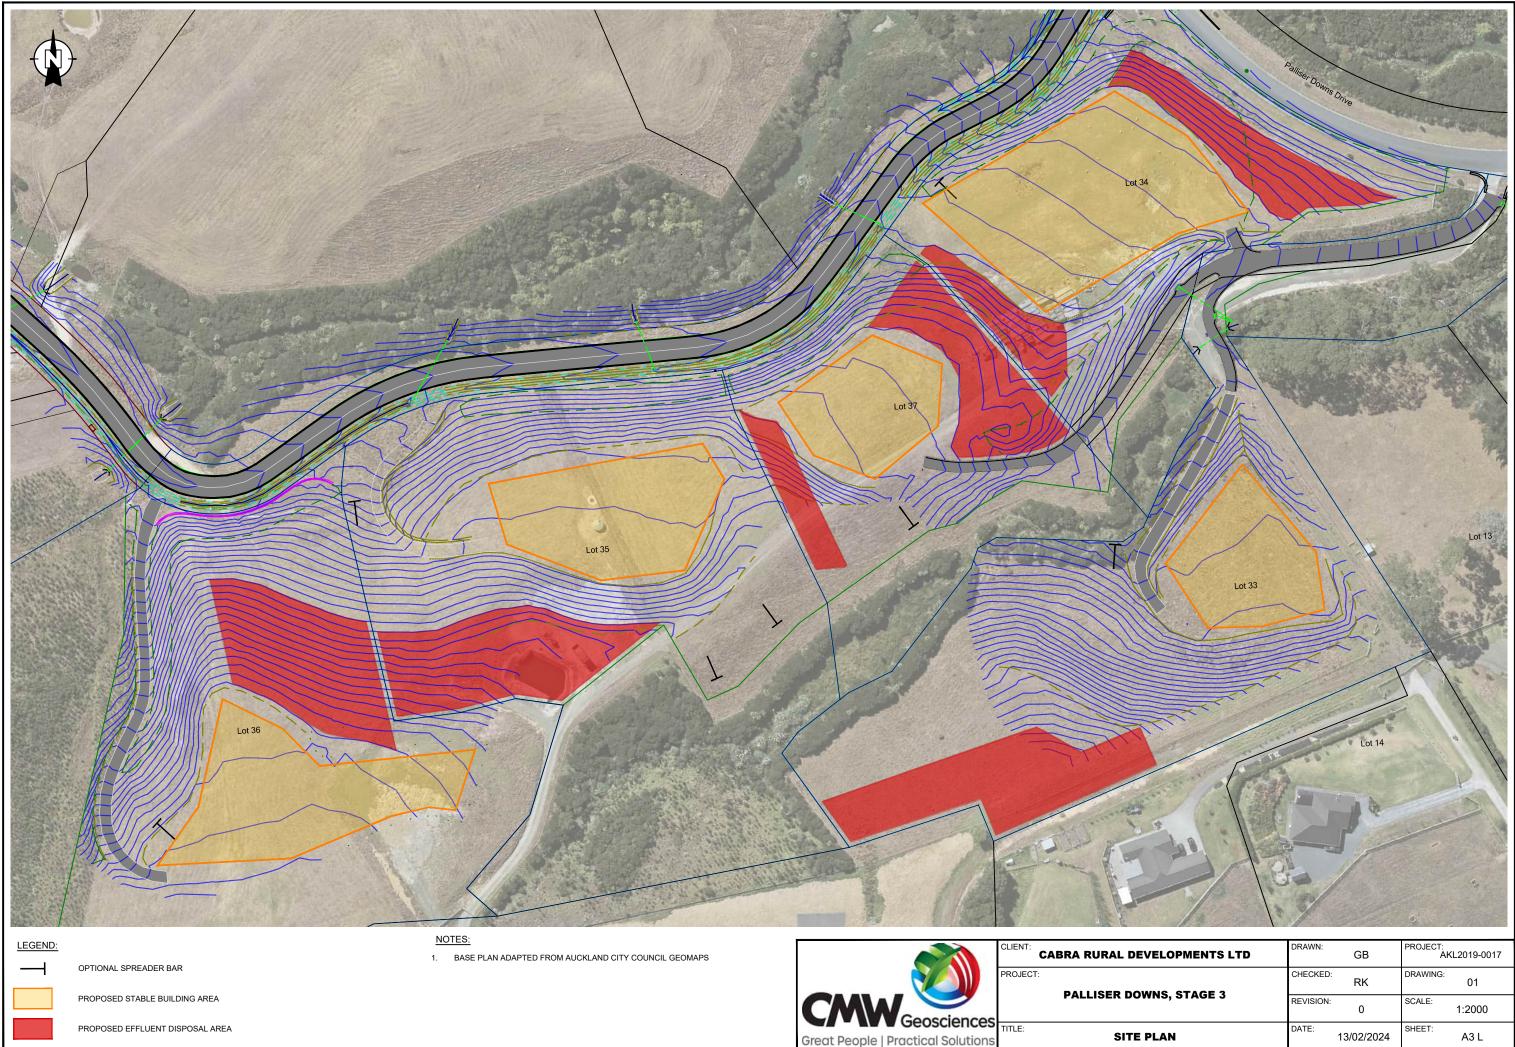
OPMENTS LTD	DRAWN:	GB	PROJECT: AKL	2019-0017
S, STAGE 3	CHECKED:	RK	DRAWING:	01
5, 31AGE 5	REVISION:	0	SCALE:	1:2000
AN	DATE:	13/02/2024	SHEET:	A3 L

The eastern portions of the Lot 36 Stable Building Area were earthworked by others prior to the works described herein. The extent of the affected area is between PT03 to PT07 on this lot depicted on appended CMW Drawings 01 to 03. Retrospective investigations indicate shallow fills here that generally appear to have been placed to an engineering standard such as our fill specification. Nevertheless, we consider it prudent for any building subgrade and foundations in this area to be subject to further engineering inspection as described in the appended Opinion of Suitability in *Appendix A*.

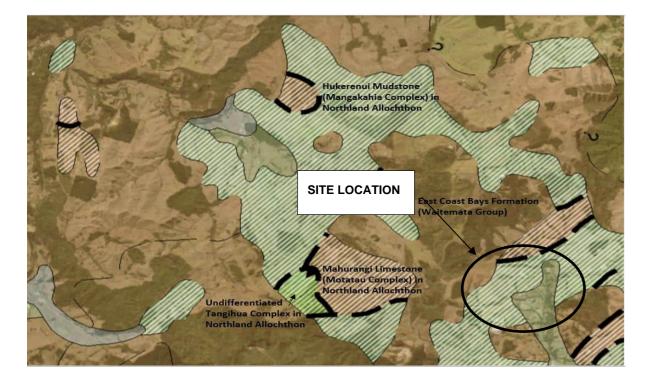
Figure 3: Regional Geological Map (GNS Geology)

The main geohazards associated with these geological units are presented below:

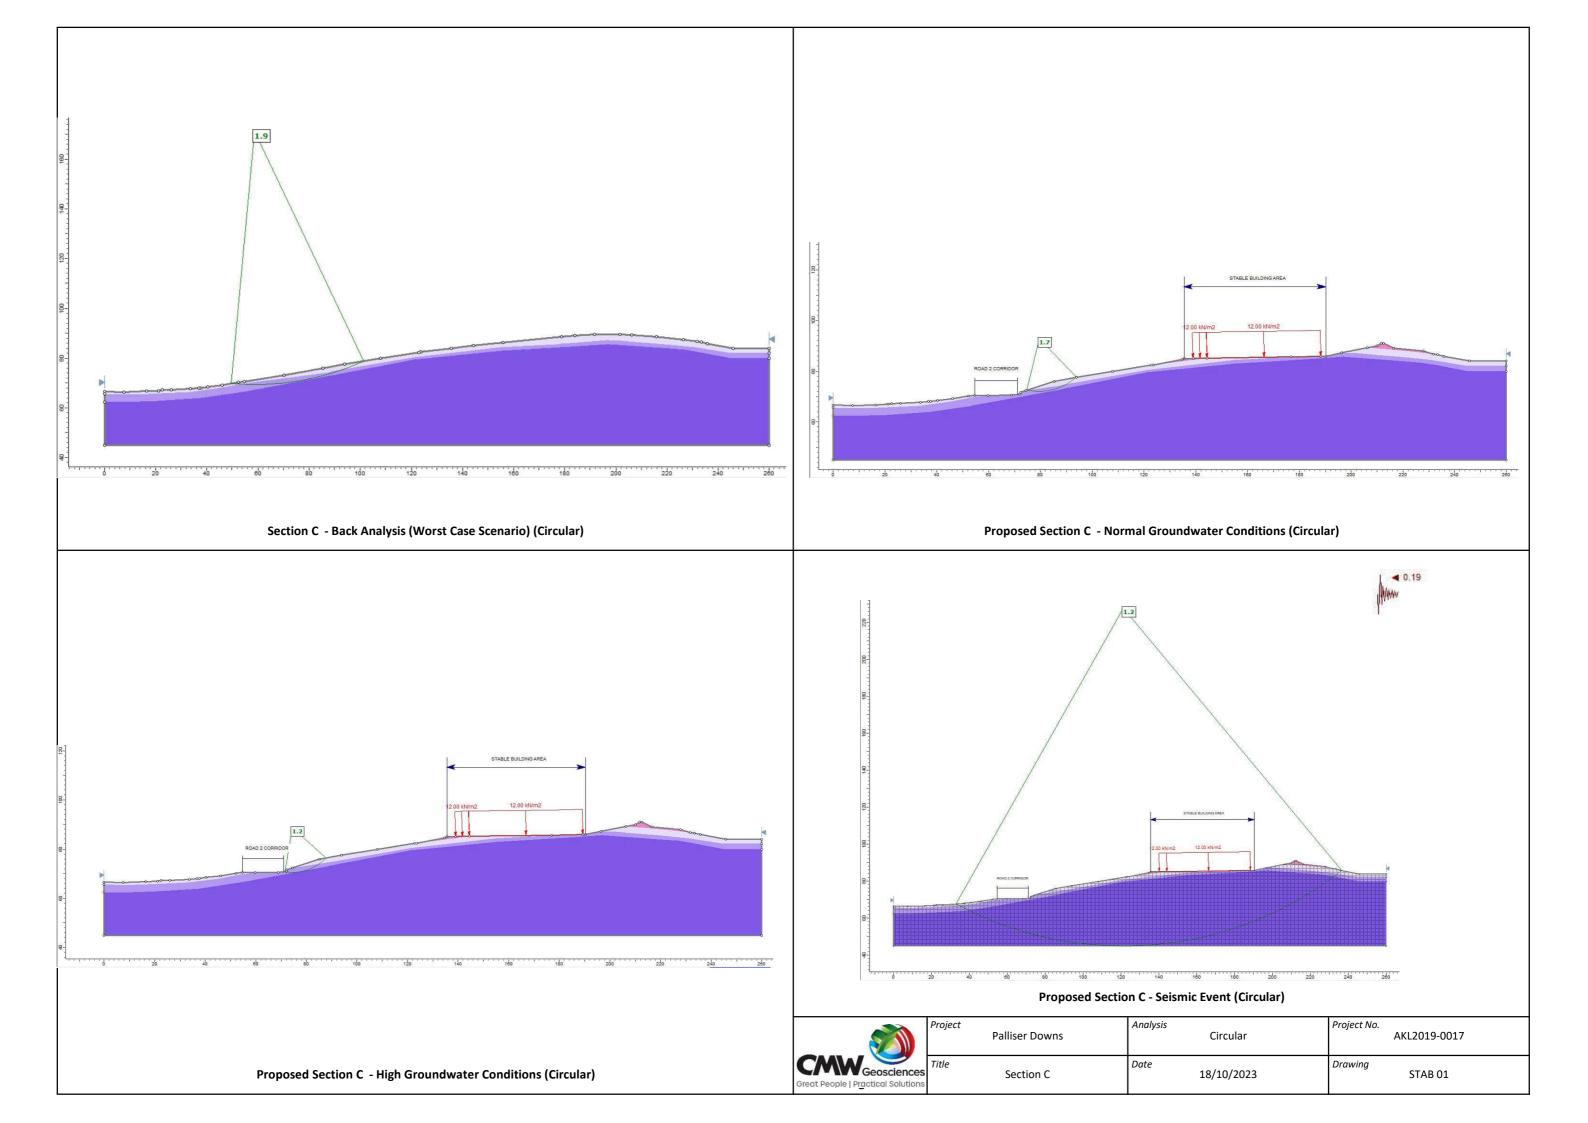
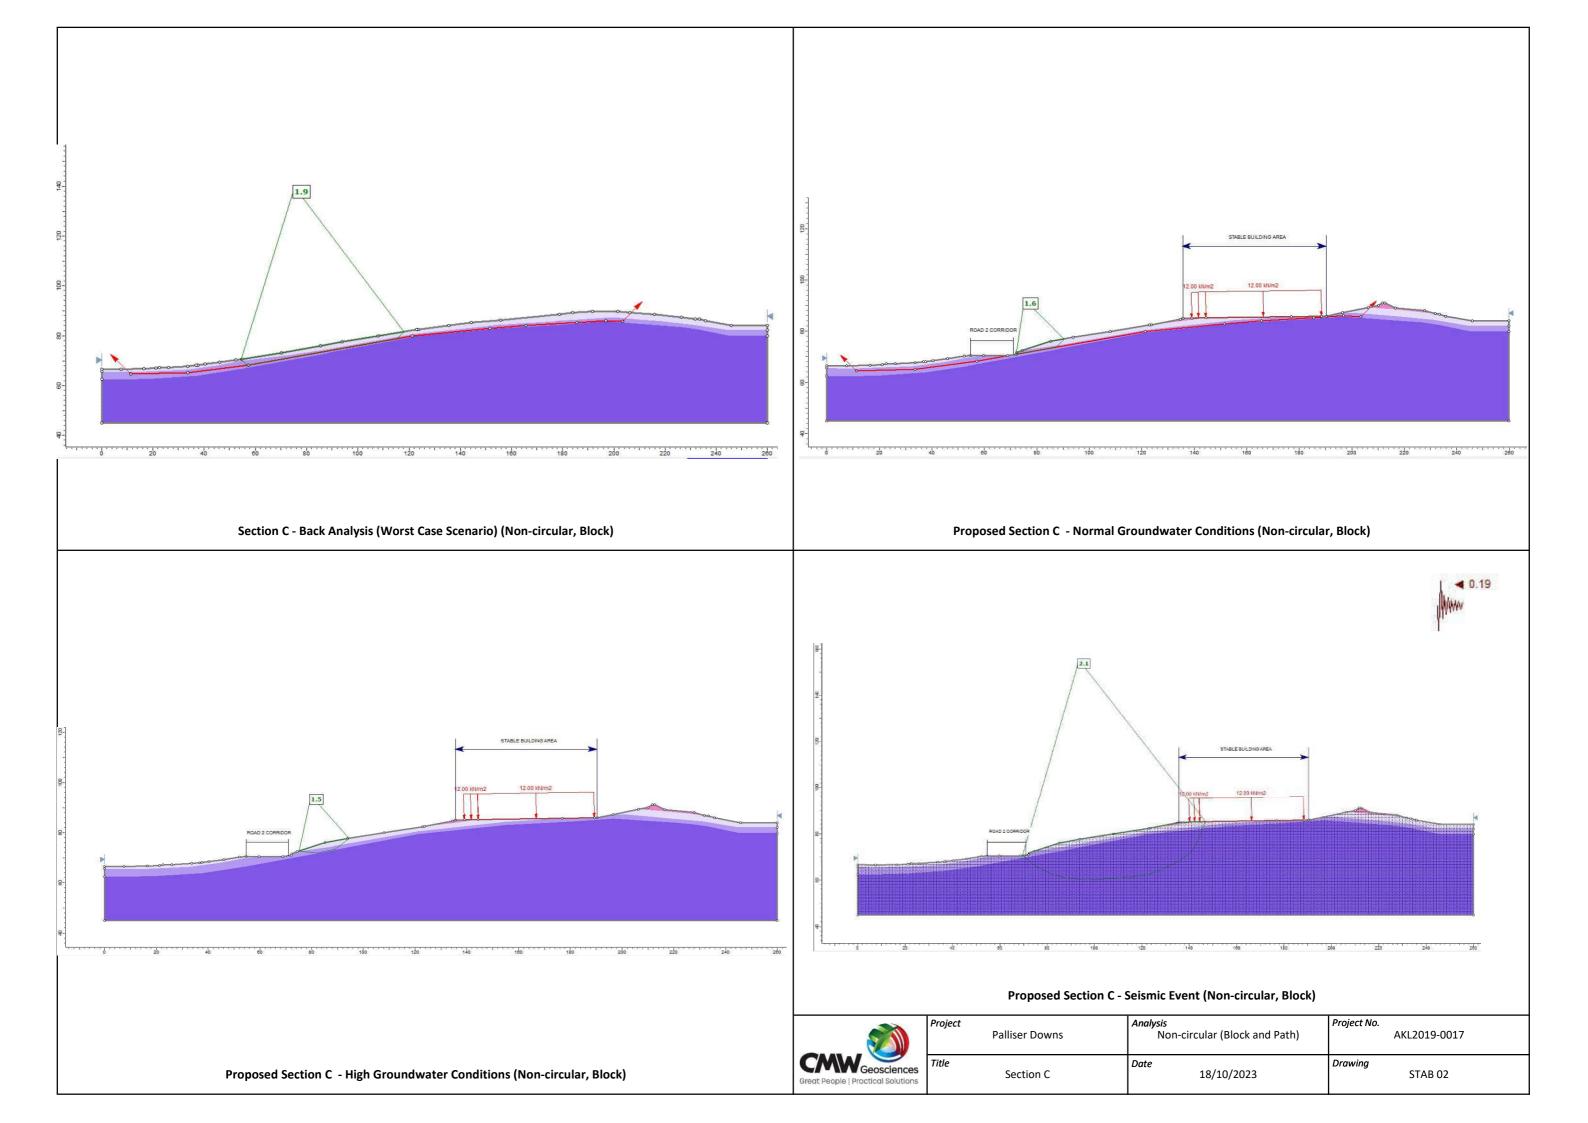
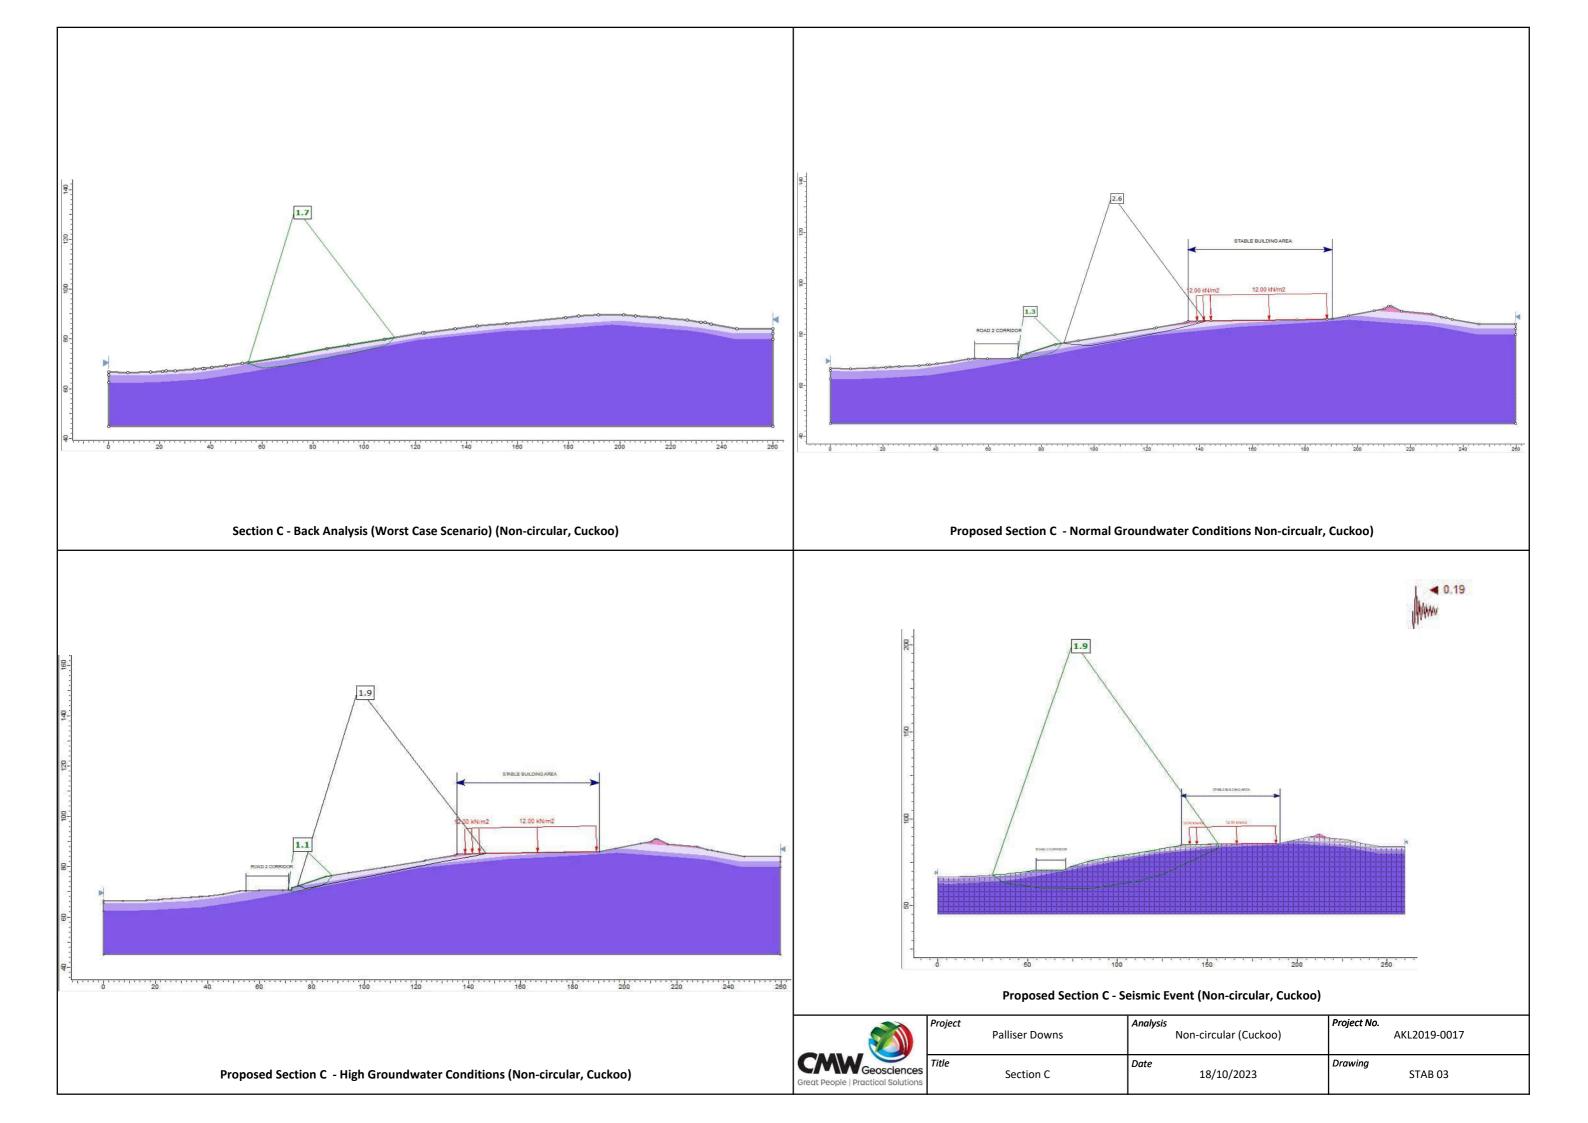
SEIS	Non-Circular (Path)	2.1	✓	Meets FoS requirements				
	Back Analysis	HGW	Non-Circular (Cuckoo)	1.7	✓					
Section C		NGW	Non-Circular (Cuckoo)	1.3	✓	Failing on area outside building platform				
Section	Proposed	HGW	Non-Circular (Cuckoo)	1.1	✓	Failing on area outside building platform				
	SEIS		Non-Circular (Cuckoo)	2.1	✓	Meets FoS requirements

Material Name	Color	Unit Weight (kN/m3)	Strength Type	Cohesion (kPa)	Phi (°)	Ru Value
Engineered Fill		18	Mohr- Coulomb	8	28	0.05
Hukerenui Mudstone (NA) Residual Soils		17	Mohr- Coulomb	5	26	0.02
Hukerenui Mudstone (NA) Transition Zone		18	Mohr- Coulomb	6	12	0.05
Hukerenui Mudstone (NA) Parent Rock		20.5	Mohr- Coulomb	20	28	0

Material Name	Color	Unit Weight (kN/m3)	Strength Type	Cohesion (kPa)	Phi (°)	Ru Value
Engineered Fill		18	Mohr- Coulomb	8	28	0.2
Hukerenui Mudstone (NA) Residual Soils		17	Mohr- Coulomb	5	26	0.5
Hukerenui Mudstone (NA) Transition Zone		18	Mohr- Coulomb	6	12	0.2
Hukerenui Mudstone (NA) Parent Rock		20.5	Mohr- Coulomb	20	28	0

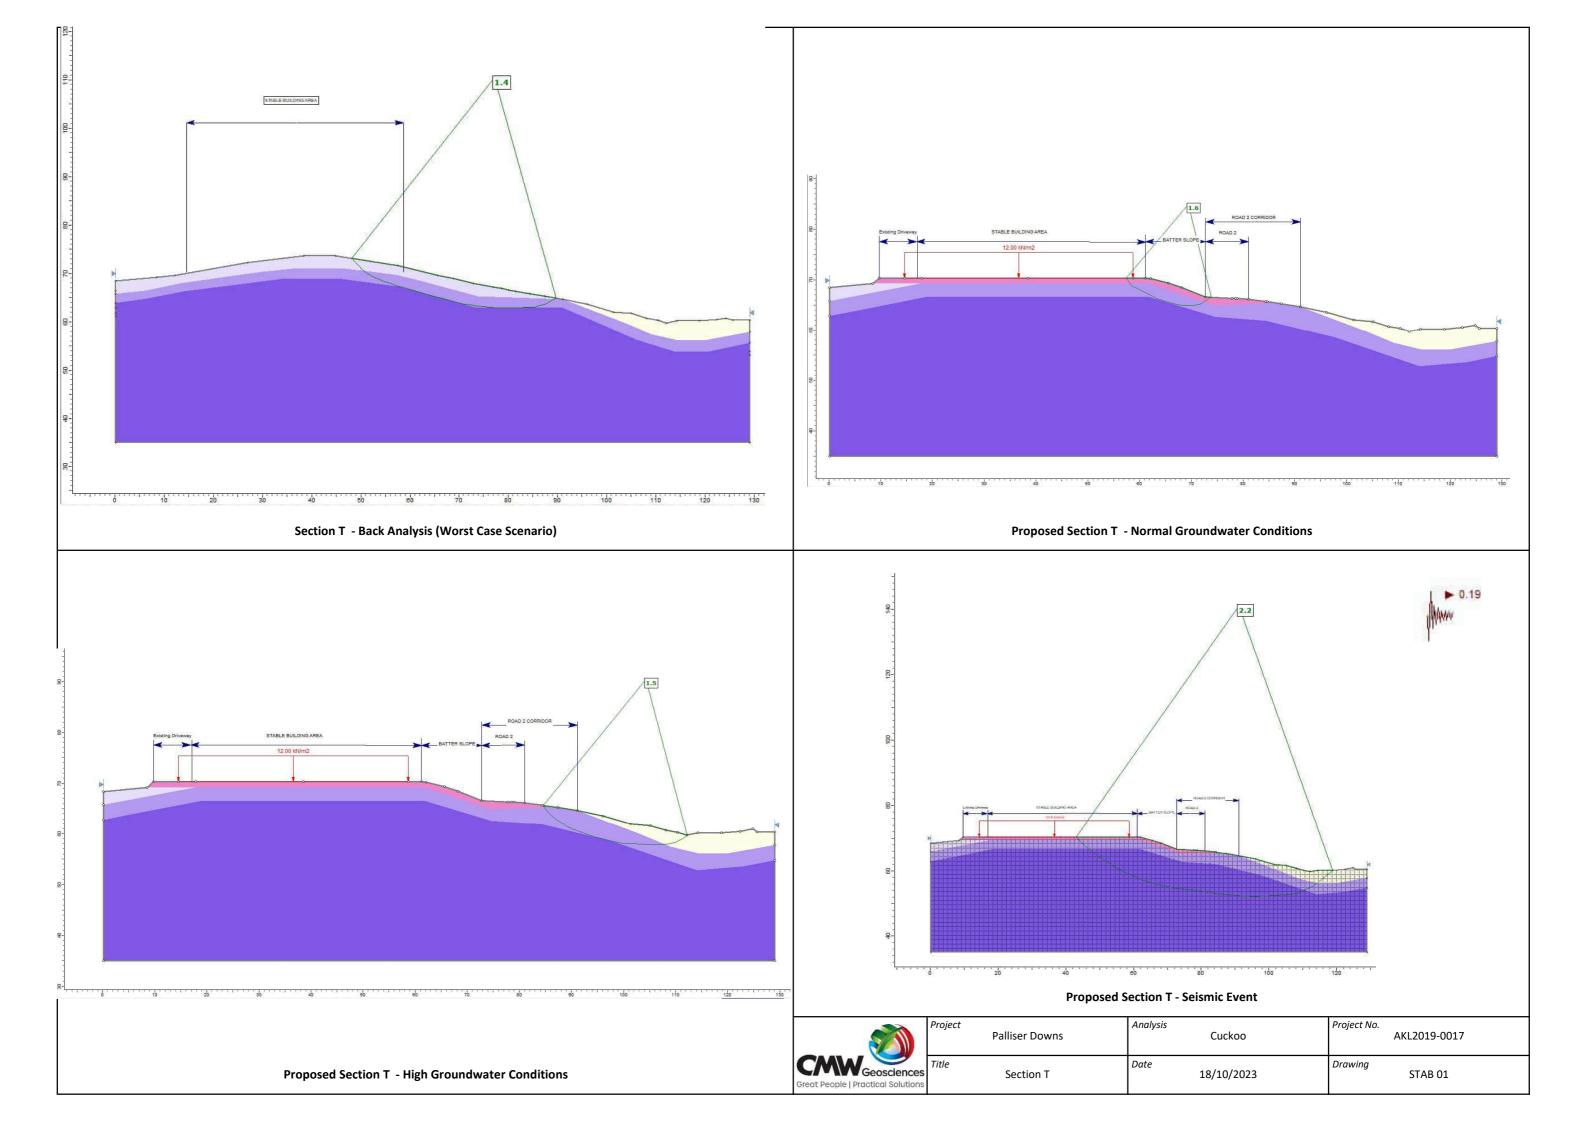
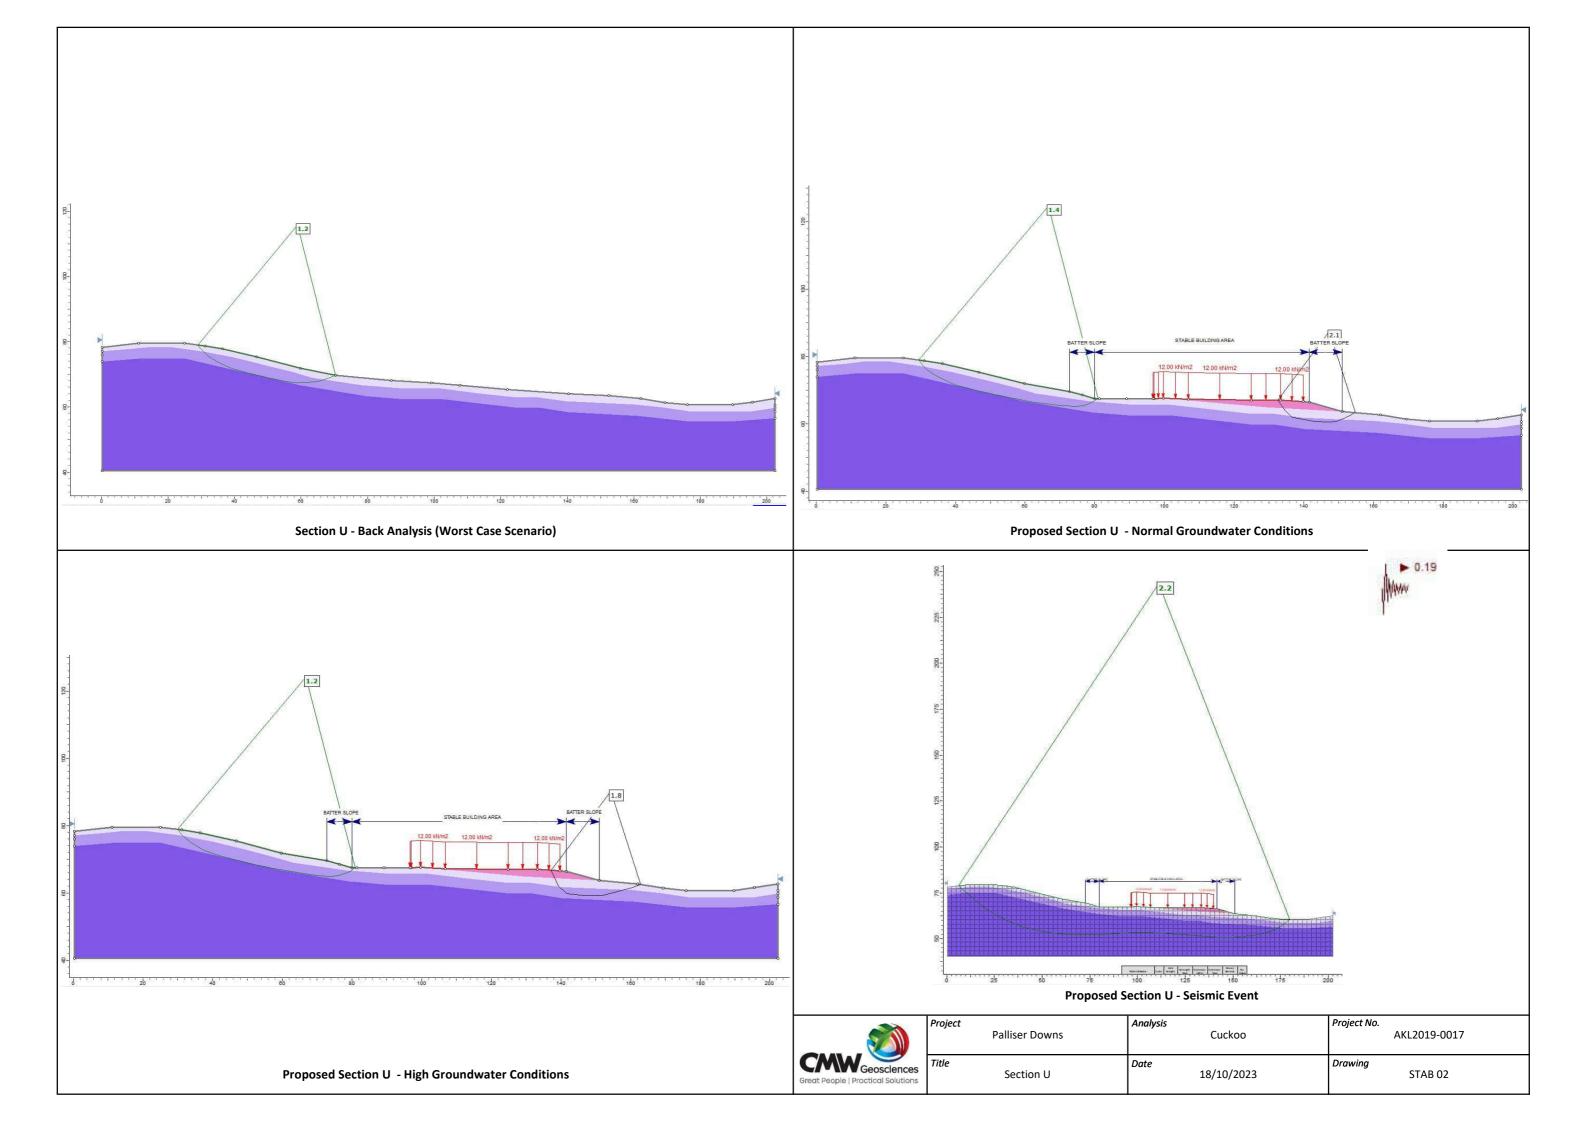
Material Name	Color	Unit Weight (kN/m3)	Strength Type	Cohesion (kPa)	Phi (°)	Ru Value
Fill		17.5	Mohr- Coulomb	8	28	0.05
Alluvium		18	Mohr- Coulomb	4	22	0.2
Hukerenui Mudstone (NA) Residual Soils		17	Mohr- Coulomb	5	26	0.2
Hukerenui Mudstone (NA) Transition Zone		18	Mohr- Coulomb	6	12	0.05
Hukerenui Mudstone (NA) Parent Rock		20.5	Mohr- Coulomb	20	28	0

Material Name	Color	Unit Weight (kN/m3)	Strength Type	Cohesion (kPa)	Phi (*)	Ru Value
Fill		17.5	Mohr- Coulomb	8	28	0.2
Alluvium		18	Mohr- Coulomb	(4)	22	0.5
Hukerenui Mudstone (NA) Residual Soils		17	Mohr- Coulomb	5	26	0.5
Hukerenui Mudstone (NA) Transition Zone		18	Mohr- Coulomb	6	12	0.2
Hukerenui Mudstone (NA) Parent Rock		20.5	Mohr- Coulomb	20	28	0
